Health Consultation

GILA CROSSING PRESBYTERIAN CHURCH

DISTRICT 6, GILA RIVER INDIAN COMMUNITY,
MARICOPA COUNTY, ARIZONA

MARCH 11, 2005

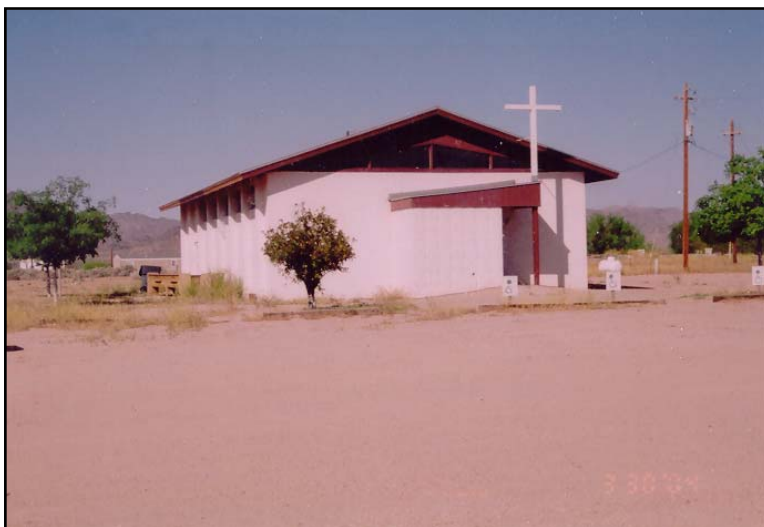
Figure 2:
District Six Gila Crossing Presbyterian Church, Main Entrance (before and after exterior remediation)

Again, the source of contamination stemmed from the renovation project at the Gila Crossing Presbyterian Church. The cleaning parishioners removed some of the furnishing from the church that contained ACM and placed them outside on church property. Also, the ACM was vacuumed and placed on the soil and in various garbage cans that are located outside the church (Appendix A photos). The asbestos was transported through the air and may have been inhaled by the painters and cleaning parishioners as they worked. Non-participants of the renovation who were outside the church may also have inhaled asbestos or ACM. Spray Solutions Environmental cleaned up the outside area on March 19, 2004 (5).

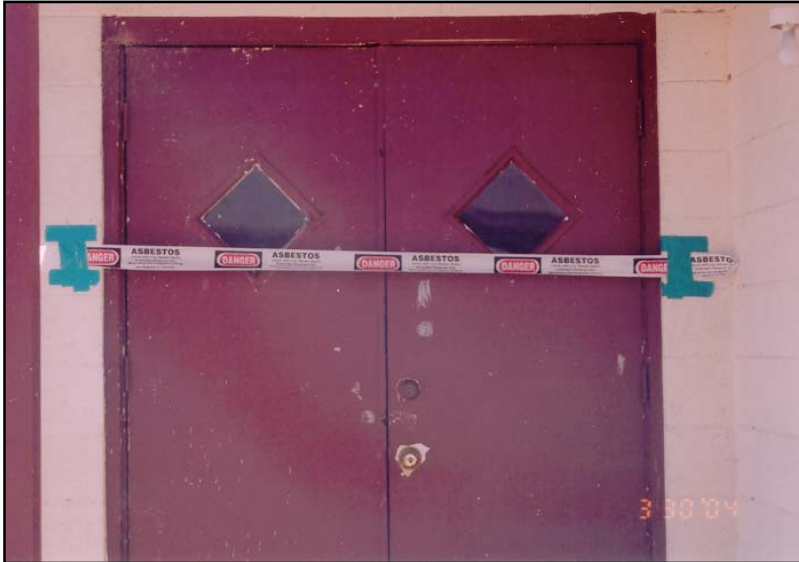
Figure 3:

Asbestos caution tape covers front door of main entrance of Gila Crossing Presbyterian Church

Currently, no one is allowed inside the Gila Crossing Presbyterian Church unless they have received proper asbestos training or the asbestos remediation is complete. A remediation service has been chosen, but the funding has not been secured to continue the remediation of the interior of the church. The exterior of the church must undergo post-soil sampling to determine if remediation is complete. Also, the Gila Crossing Presbyterian Church property boundary must be sampled to determine if asbestos may have reached neighboring properties.

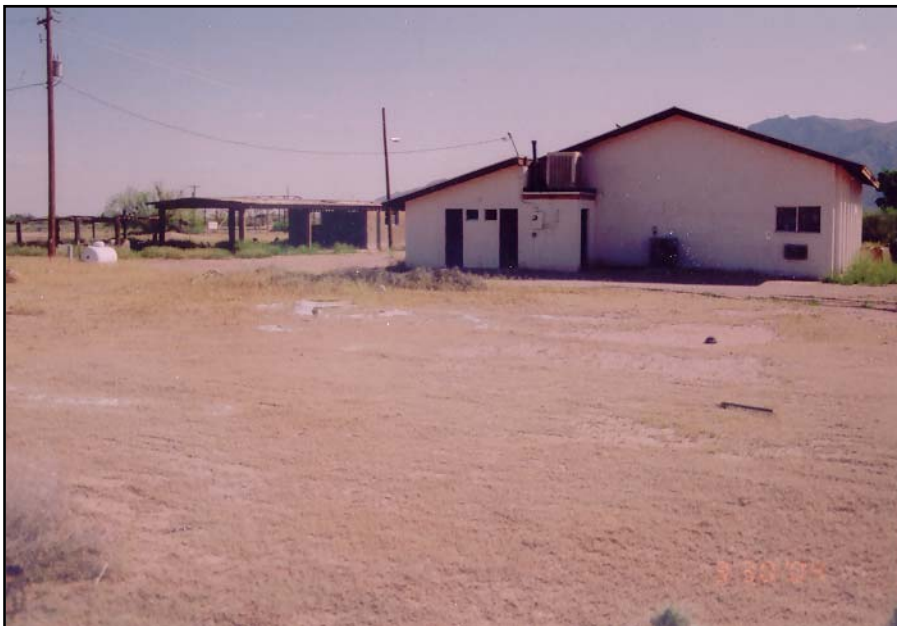
Figure 4:

White asbestos in soil located behind the church

Soil outside the church was contaminated with chrysotile asbestos by the transport of ACM that was either vacuumed or was on the furniture that was removed and subsequently, placed on the soil. Non-participants of the renovation who were outside the church may also have inhaled asbestos or ACM. This area was cleaned by Spray Solutions Environmental on March 19, 2004, but no post soil sampling was conducted.

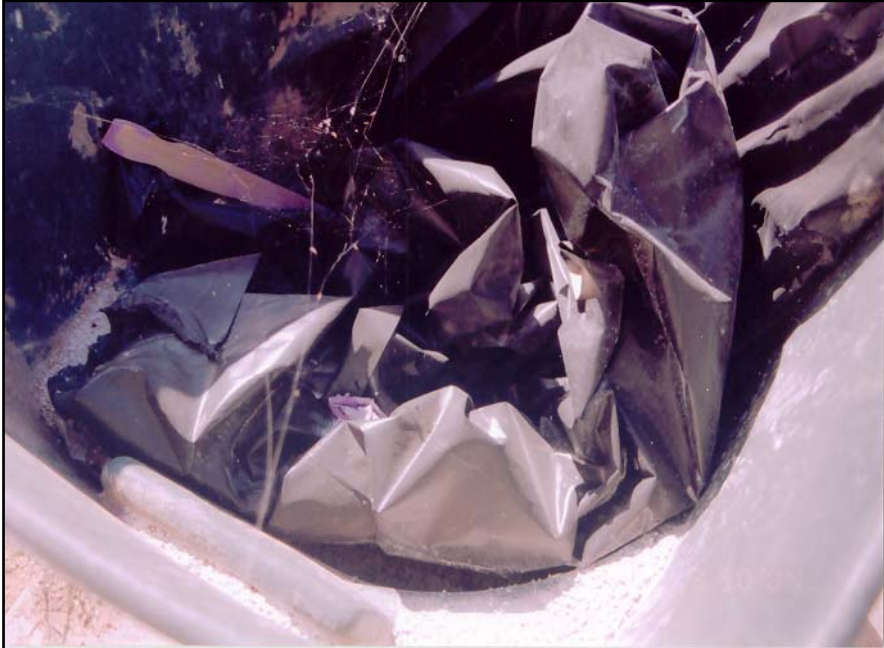
Figure 5:

Asbestos Containing Material (ACM) is in lower center of garbage can which was located outside of church

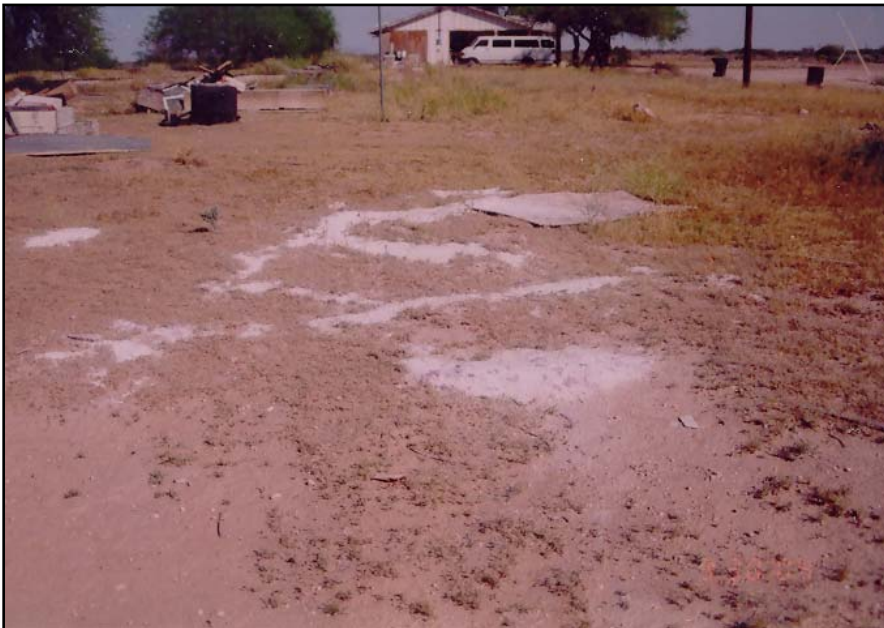
Figure 6:

In the background is the groundskeeper's residents. In the foreground is white asbestos on the soil east of church

On May 18, 2004, two asbestos samples were taken from the groundskeeper’s residence and the results were negative (8).

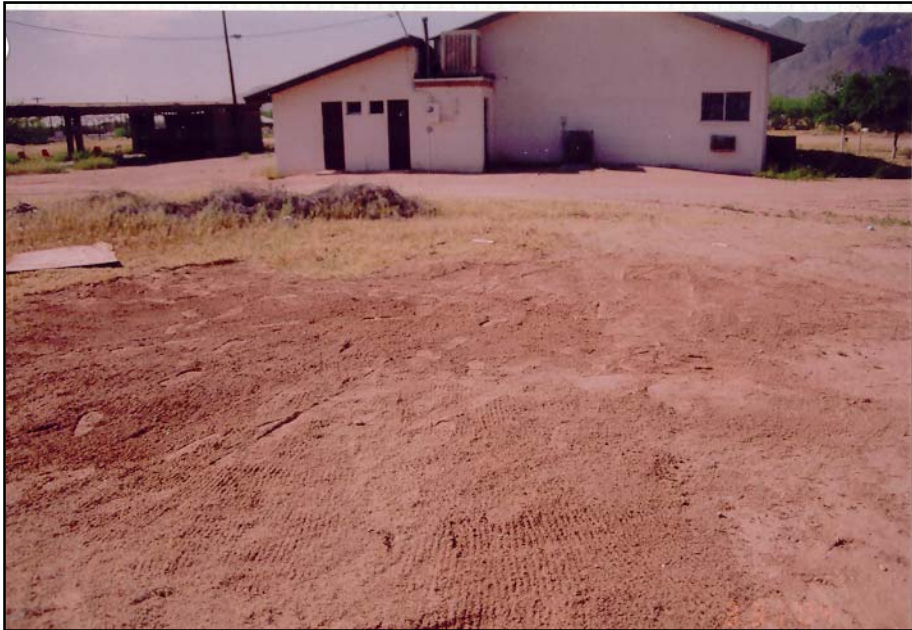
Figure 7:
Remediated area located behind the Gila Crossing Presbyterian Church
